# **Surface-Tolerant Coatings for Aircraft Hangars, Flight Control Tower, and Deluge Tanks at Fort Campbell**

Final Report on Project AR-F-320 for FY05

June 2007

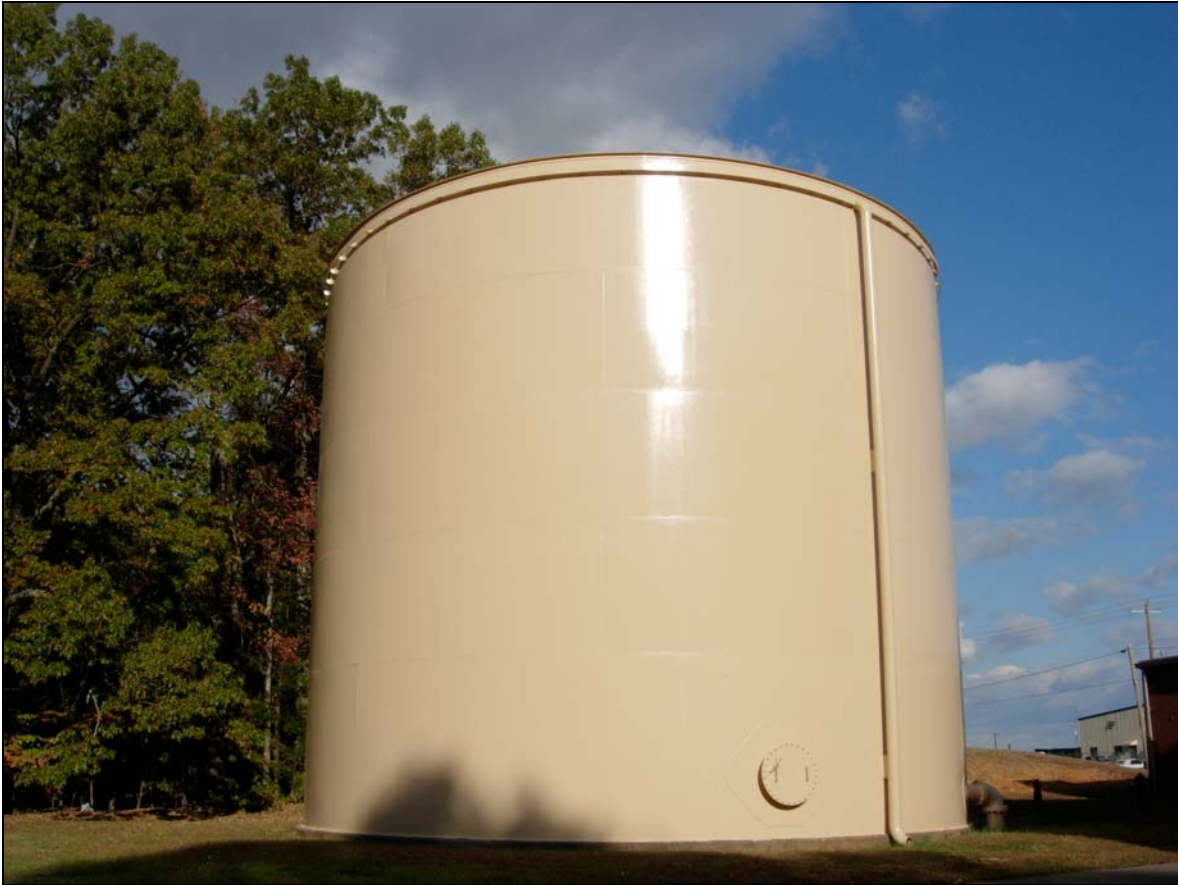
**Figure 11: Sabre Deluge Tank after application of the coating system by MANTA**

**GENERAL CONDITION:** The exterior of the Sabre Deluge Tank consists of approximately 5,806 square feet. It is constructed of steel and was previously painted. MANTA applied the Sherwin Williams Corothane I Mastic primer and the Sherwin Williams Corothane I Ironox A topcoat on this structure.

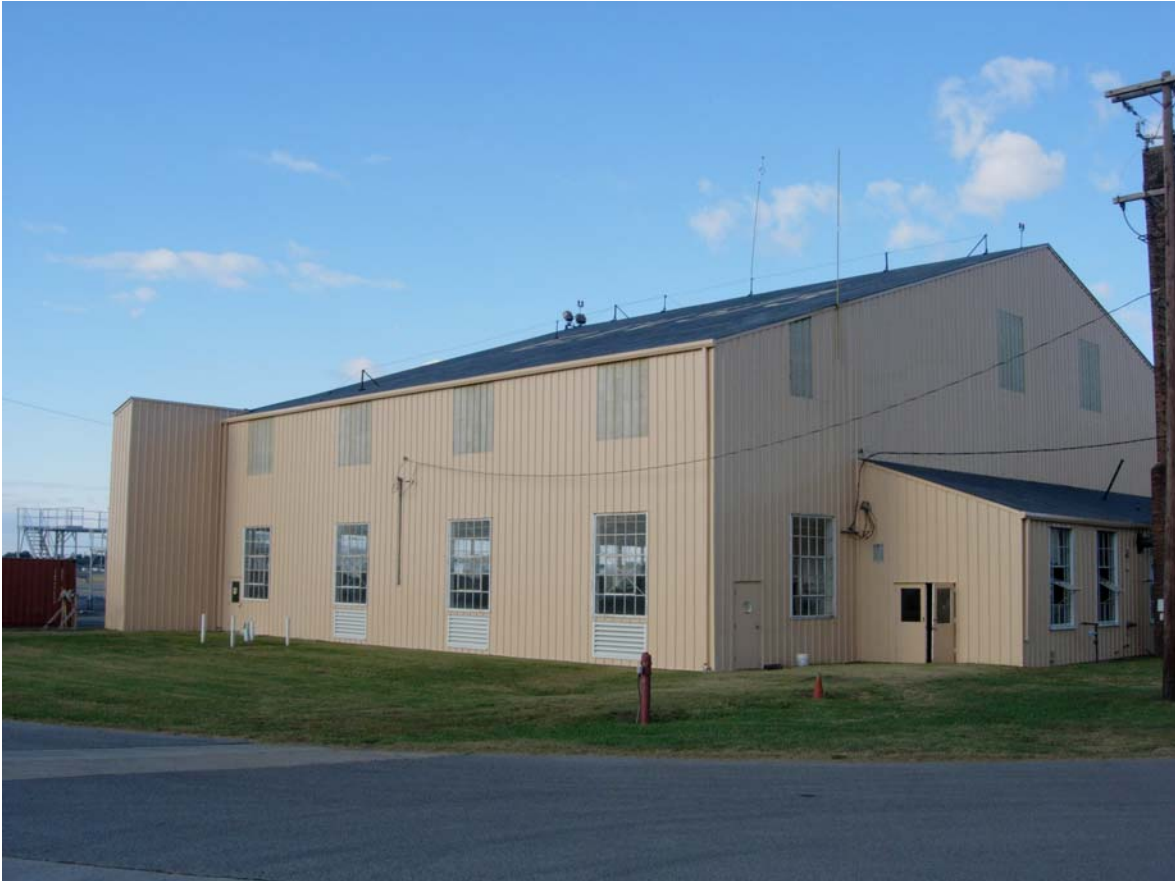
**HANGAR #1 – BUILDING 7161**

**Figure 17: Hangar #1 upon Completion**

At the time of the in-progress inspection, in September 2005, numerous issues were identified with Hangar #1. The primary issue observed at the time was loosely adhered paint that was not removed in accordance with the requirements of SSPC SP3. MANTA has done an outstanding job of correcting this issue. During the final inspection, no visible detrimental issues with MANTA's work were observed on Hangar #1.

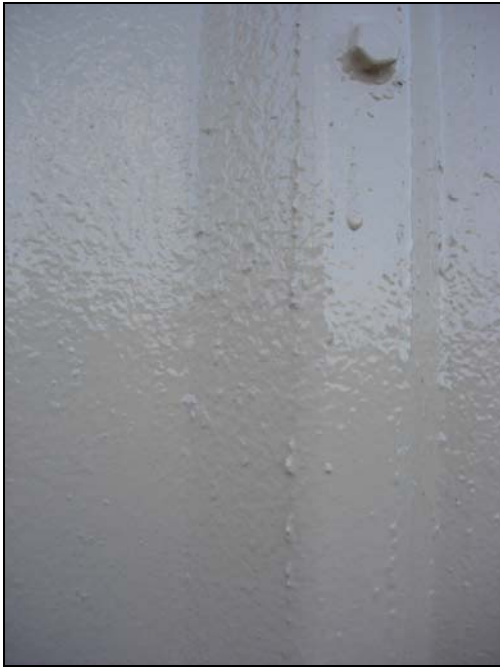
The pictures shown below provide graphic examples of the effort expended by MANTA during the time between the in-progress inspection and the final inspection. The pictures on the right (Figure 19 and Figure 21) were taken during the in-progress inspection. They show extensive loose paint that required removal. The pictures on the left (Figure 18 and Figure 20) show the Hangar #1 surfaces at the time of the final inspection.

**Figure 18: Final Inspection (Hangar #1)**

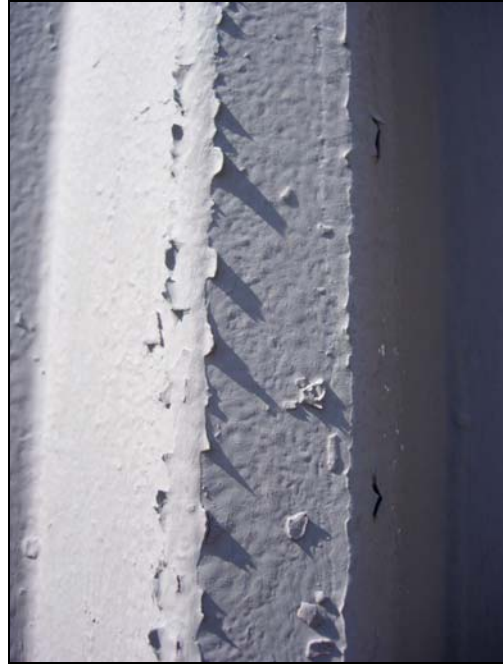
**Figure 19: In-Progress Inspection (Hangar#1)**

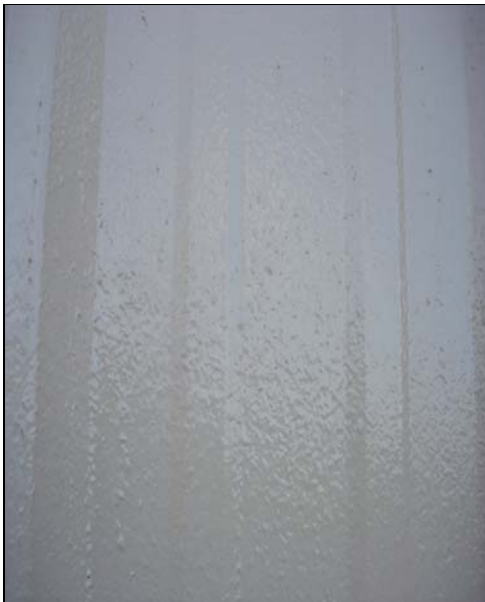
**Figure 20: Final Inspection (Hangar #1)**

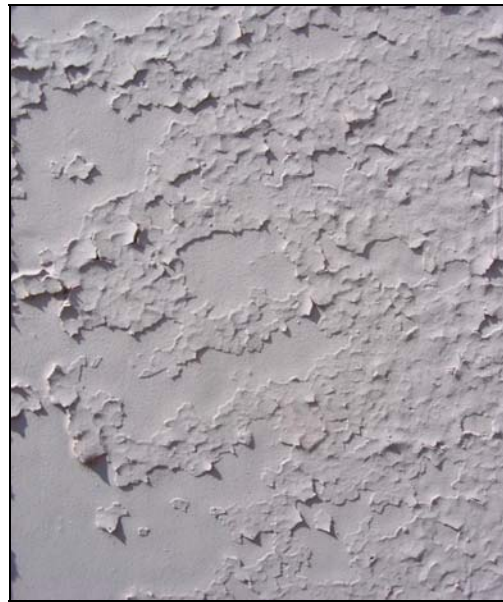
**Figure 21: In-Progress Inspection (Hangar#1)**

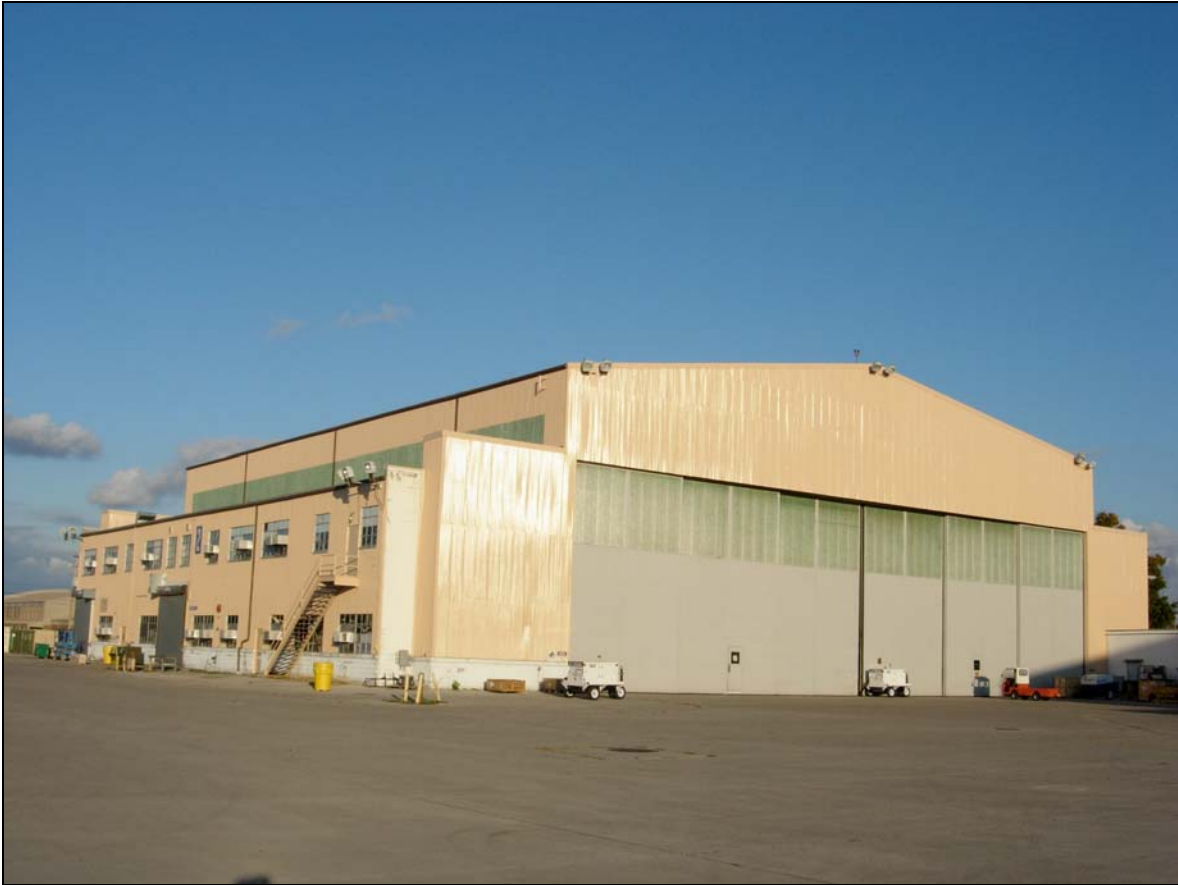
**HANGAR #2 – BUILDING 7156**

**Figure 22: Hangar #2 Ft. Campbell upon Completion**

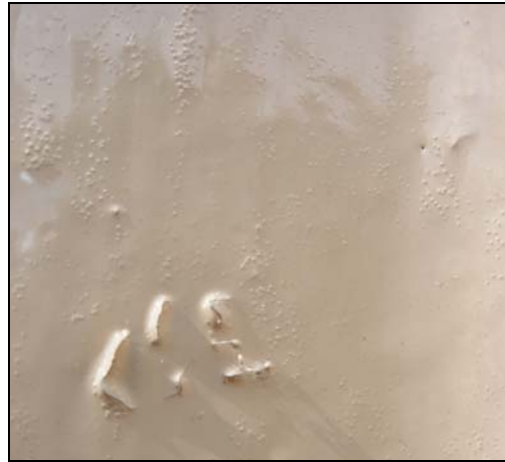
Roller nap and brush hairs were observed in several locations on Hangar #2. They were embedded within the topcoat film.

**Figure 30: Roller nap in topcoat film**

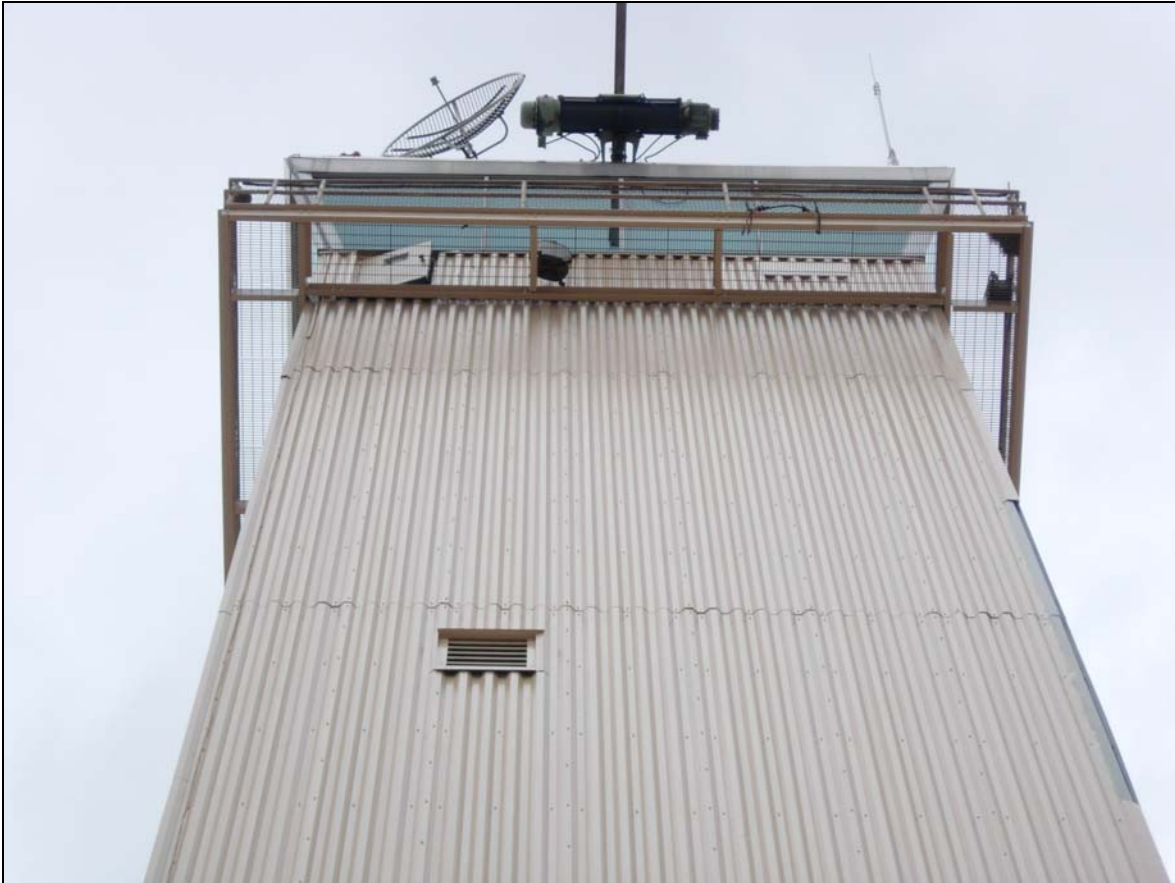
**FLIGHT CONTROL TOWER – BUILDING 7212**

**Figure 33: Close-up of the Flight Control Tower upon Completion**

- A few pieces of siding are missing or damaged on the edges of the structure (the right hand portion of Figure 33 shows one missing piece).
- Some of the corrugated metal was damaged (i.e. dented).
- One area was observed where the coating was curled or lifted from the surface.
- One areas was observed where the coating was damaged and needed minor repair
- One area was observed with a missed area parallel to a caulked seam around a vent

These missing and/or damaged corner siding pieces and the dented siding represent pre-existent conditions that were present before MANTA began work on this structure and were noted in the In-Progress Inspection Report.

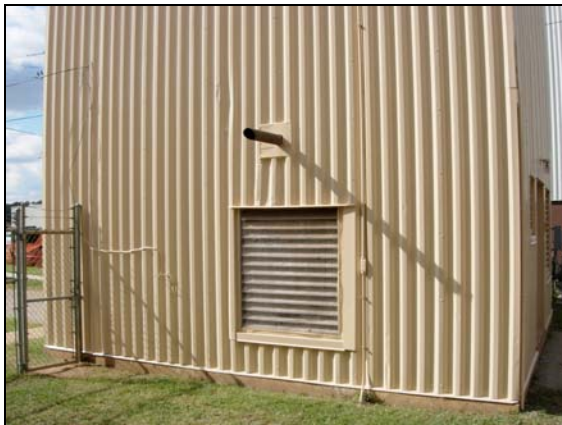
The coating in one area near the gate was damaged in two spots. This appears to be due to some type of mechanical damage, possibly related to the gate-latch device. MANTA touched up these damaged spots during the final inspection. If the gate-latch device caused the coating damage, it is likely to reoccur in this area unless it is corrected.

**Figure 38: Long view of gate area**
